Pedestrian Safety Study

US 13 and US 40

New Castle County, Delaware

Prepared for:
Delaware Department of Transportation

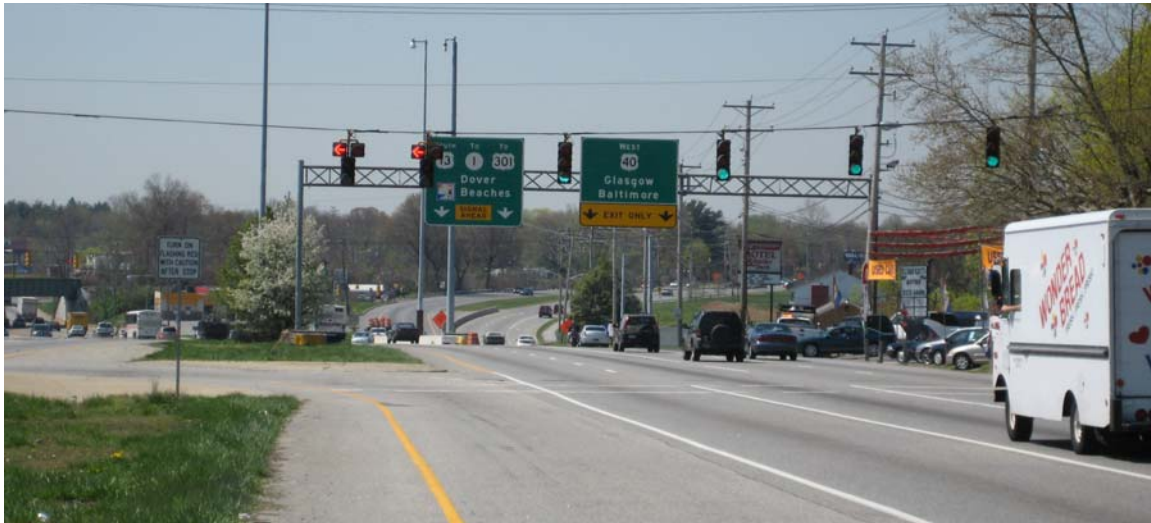
Photo 1 : US 13 & US 40 Split

US 13 north of the intersection with US 40 is an eight-lane divided highway with a grass median. This portion of the corridor is almost entirely commercial. At the intersection with US 40, US 13 splits with four lanes continuing on US 13 and four lanes on US 40. South of the US13/US40 split, land uses transition to mixed land uses including high density residential and strip commercial.

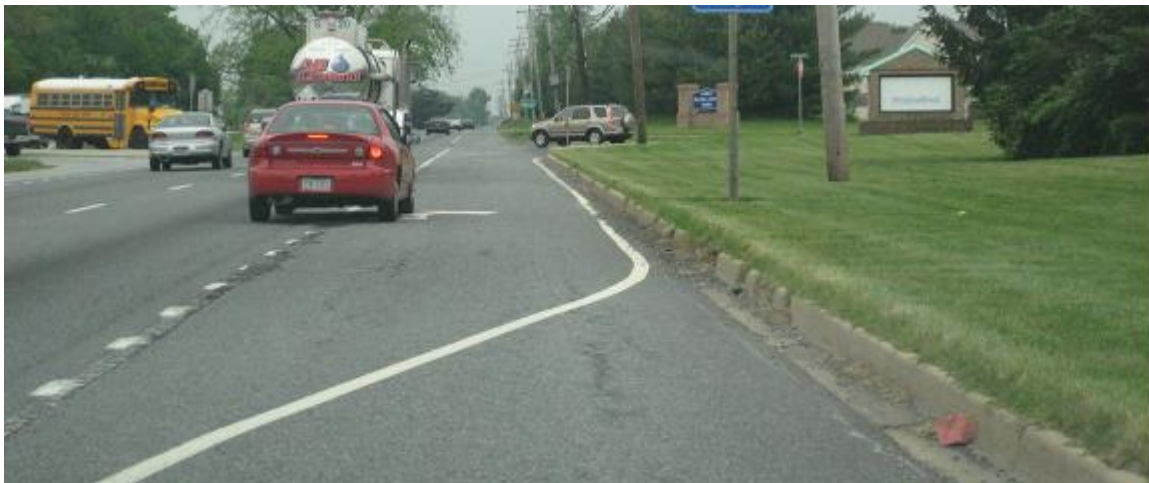
Photo 2 : US 13 & Buena Vista Drive

At each intersection on the northbound side of US 13 there are two thru lanes with one exclusive right turn lane and a left turn lane. For each intersection on the southbound side of US 13, there are two thru lanes and one left turn lane. At the intersection with Buena Vista Drive US 13 has an additional right turn lane on its southbound side (**Photo 2**).

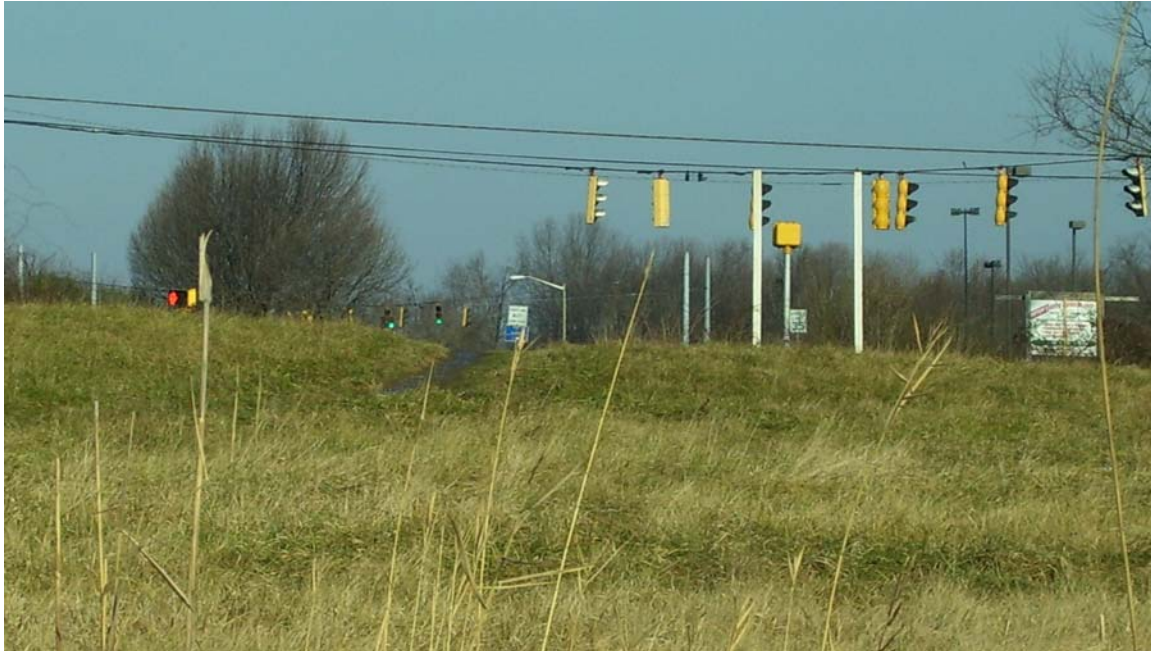
Photo 3: Pathway leading to US40 and Wilton Boulevard

At the intersection of US 13 and Llangollen Boulevard, there is a pedestrian crosswalk with pedestrian signal heads on the north side of the intersection. There is also an unofficial worn pedestrian path leading from behind the new commercial strip-mall at this intersection across a grassy area and railroad tracks to the intersection of US 40 and Wilton Boulevard (see **Photo 3**). Asphalt sidewalks exist on the east side of US 13 in this area between Llangollen Boulevard and the Beaver Brook Shopping Center at Saienni Boulevard, where pedestrian crosswalks and signal heads are located on the south side of the intersection.

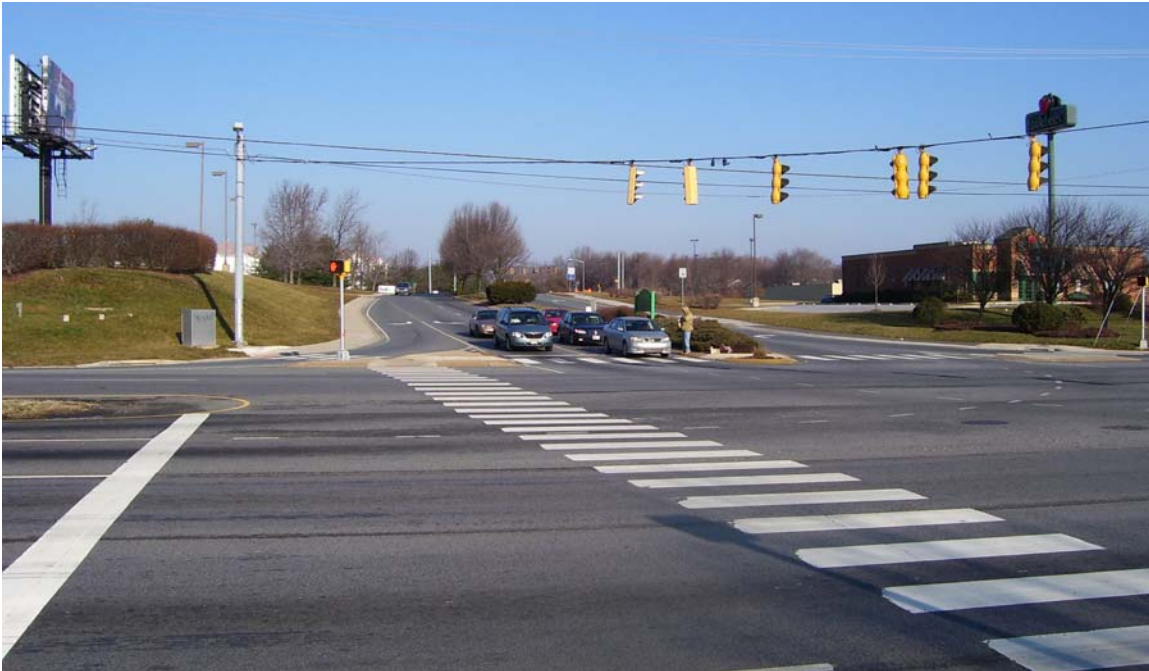
Photo 4: Crosswalk on west side of the intersection

At the intersection with Wilton Boulevard, the eastbound traffic lanes consist of two thru lanes and two left turn only lanes. The westbound traffic lanes have two thru lanes, one U-turn lane and one right turn only lane. Crosswalks exist across the Wilton Boulevard approach and on the west side of the intersection. Each crosswalk has pedestrian push buttons and pedestrian signal heads. The unofficial pedestrian path leading from the US 13 and Llangollen Boulevard intersection leads directly to the south side of this intersection (**Photo 4**). There are no sidewalks on this side of the intersection. Sidewalks are located on Wilton Boulevard, and along the north side of US 40.

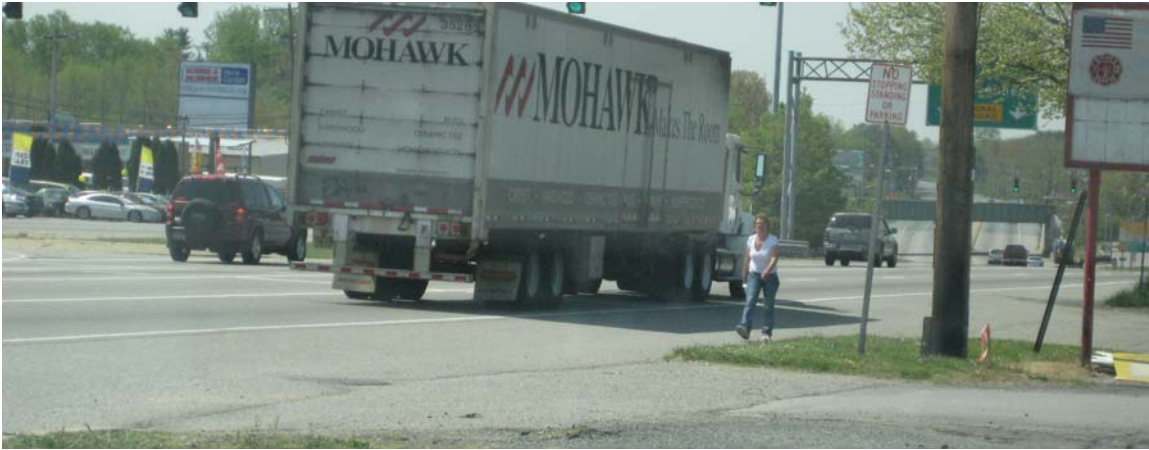
Photo 5: Pedestrian walking on southbound shoulder of US 13, north of the US 13/40

Pedestrians were observed traveling in the northbound and southbound shoulders along this section of US 13 (**Photo 5**). A particular travel route that was noted was pedestrians originating from the area of Llangollen Boulevard traveling northbound in either shoulder, navigating through the US 13/40 intersection, and continue northbound in the grass median until a break in southbound or northbound traffic occurs for them to cross to a shoulder. It was observed that many pedestrians were using this movement to arrive at either the Motel 6 on the southbound side of US 13 or Hooters restaurant on the northbound side of US 13. Some pedestrians were observed continuing north towards the DE 273 intersection in the grass median. Weekday pedestrian movements for this location are provided in **Figure 3**.

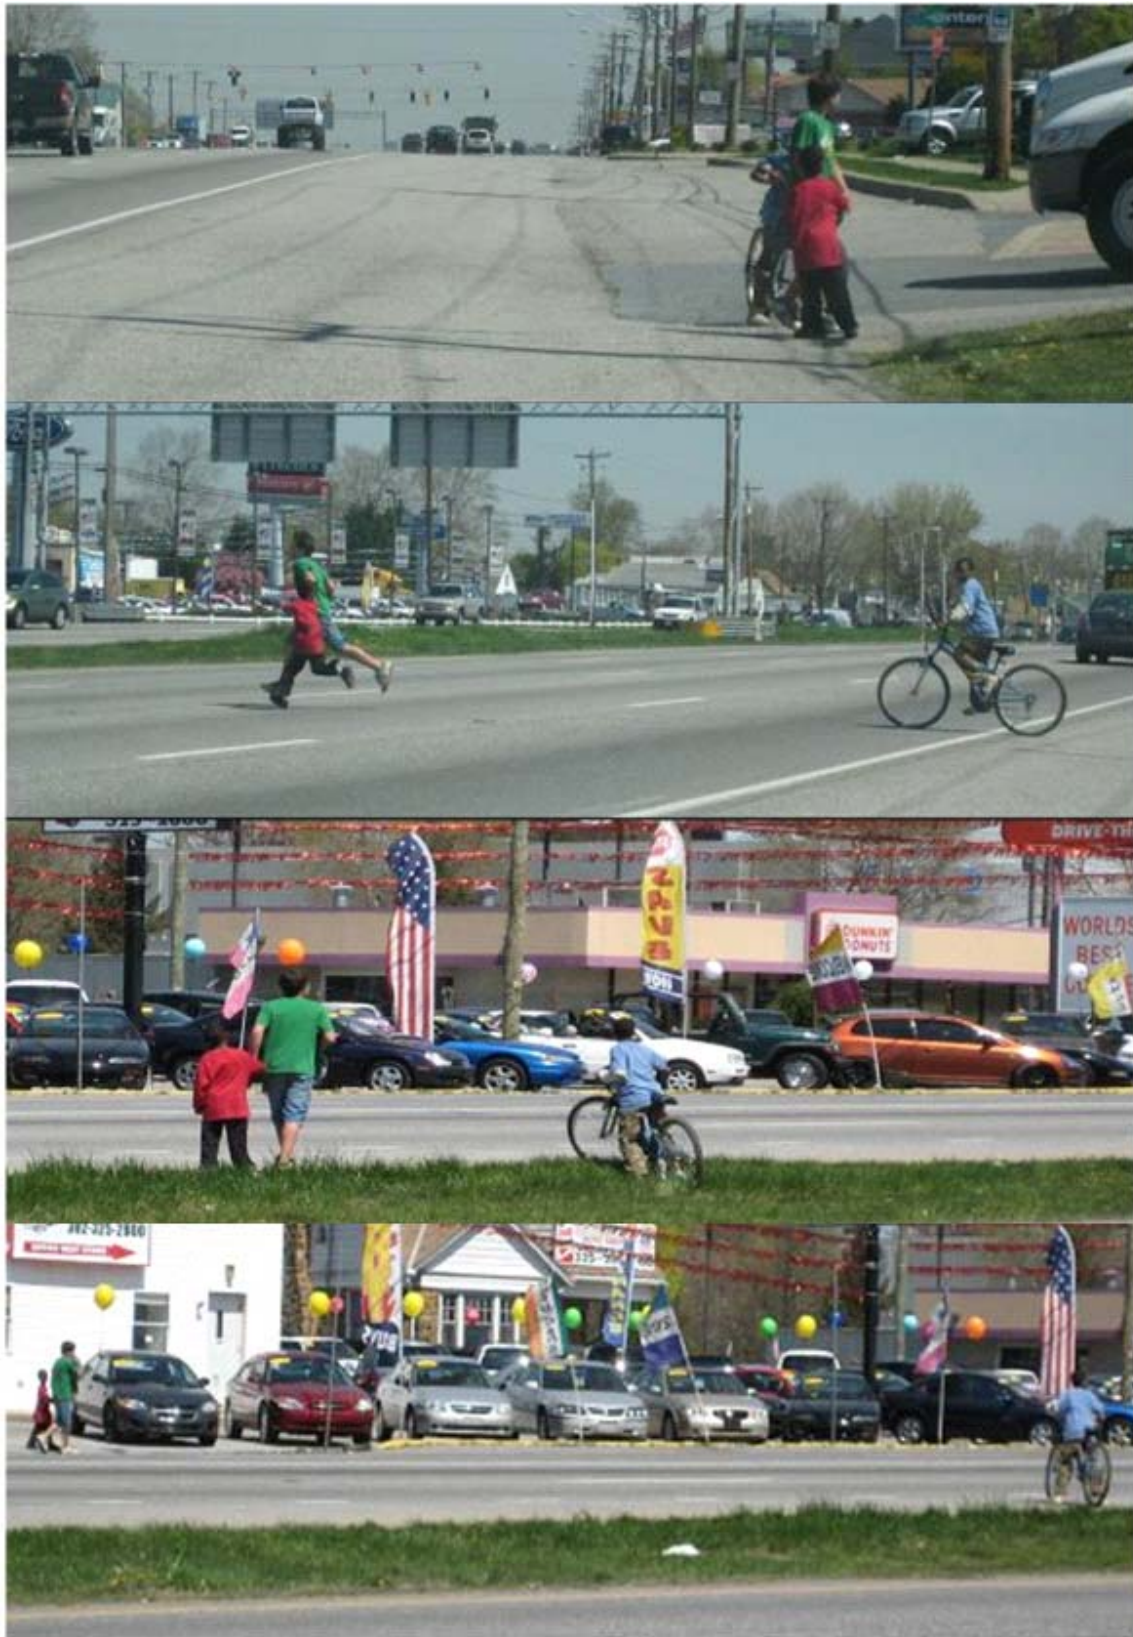
Photo 6: Children crossing US 13 north of the US 13/40 split

A particular example of the pedestrian activity can be seen in **Photo 6**. During the mid-day peak period, children were observed crossing US 13 just north of the US 13 & US 40 split. It was noted that at the time **Photo 6** was taken, traffic was observed to be very heavy.

The children waited in the northbound shoulder for approximately two minutes before finding a gap in traffic. The two children on foot ran to the grass median for safe passage. The child on the bicycle appeared hesitant and waited approximately two more minutes for a longer gap in traffic and eventually joined the other children in the grass median.

US 13 between US 40 and DE 273: In an effort to discourage pedestrians from crossing midblock on US 13, fencing or barriers along the medians could be considered. Fencing is typically used to deter pedestrians from crossing roads, railroad tracks, and other similar situations. Although, no studies examining their effectiveness could be located, fencing can be an attractive solution for deterring pedestrians, and therefore more accepted by the community. This recommendation on the use of fencing to deter pedestrians from crossing at midblock locations is pending further investigation.

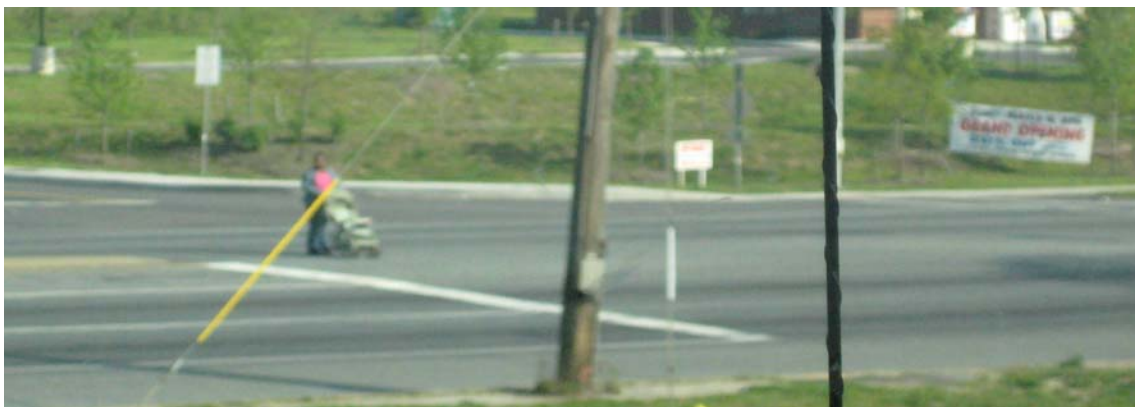
Photo 7: Pedestrian with baby stroller crossing US 13 at Llangollen Blvd

It appeared that the majority of these pedestrians crossed US13 and continued on a worn pathway behind the strip-mall to the intersection of US 40 and Wilton Boulevard, where the pedestrians would cross US 40 and continue towards Wal-Mart. Many of the same pedestrians were observed returning via the same route later in the day. This was observed during both weekday and weekend operation.

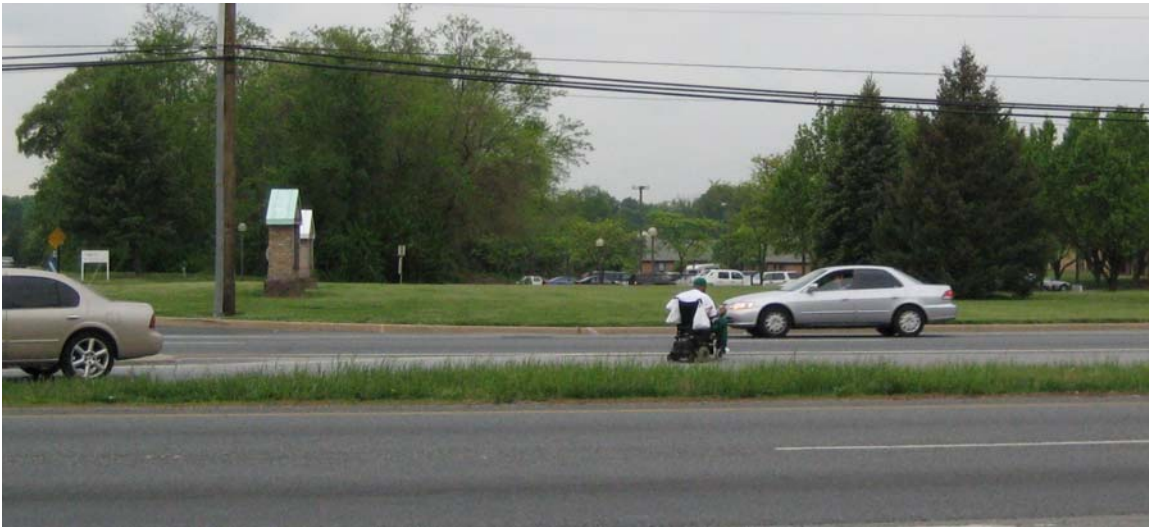
Photo 8: Man in wheelchair crossing US 13 near Buena Vista Drive

The intersection of US 13 and Buena Vista Drive is an unsignalized intersection with U-Turn lanes in the median for US 13 traffic. Vehicles on Buena Vista Drive are not permitted to turn left onto US 13. There are sidewalks on the east leg of Buena Vista Drive, as well as on the south-west corner. There are two bus stops located near the intersection, a covered bus stop on the north-east corner and a regular stop on the south-west corner. Although there are no crosswalks at this intersection, there were a significant number of pedestrians (22) observed crossing both US 13 and Buena Vista Drive (**Figure 5**) including a man in a wheelchair (**Photo 8**).

Most of the pedestrian activity at this intersection involved individuals walking to and from the residential areas. It appeared that pedestrians were using Buena Vista Drive to access the Beaver Brook Shopping Center located at Saienni Boulevard. These observations were noted during both weekday and weekend operation.

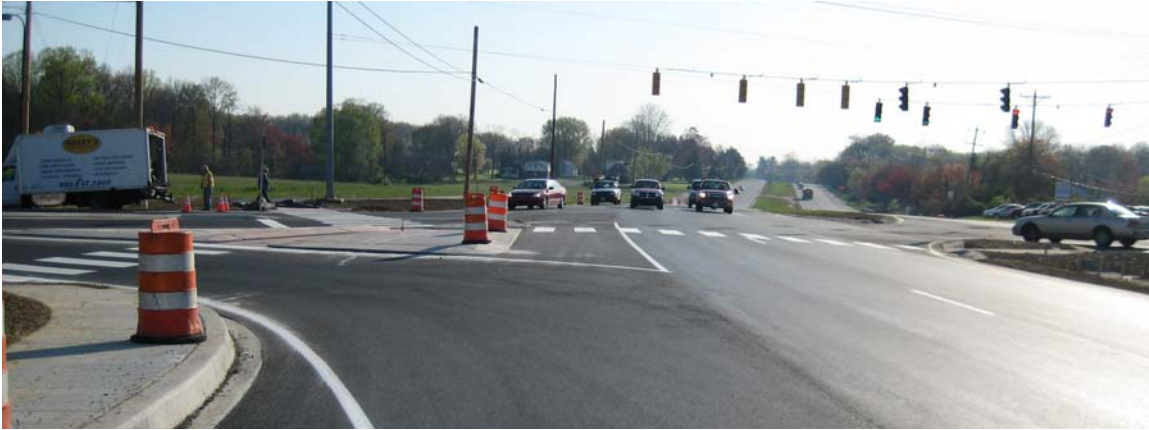
Photo 10: Intersection of US 40 and School Bell Road

Minimal pedestrian activity was observed along US 40 between Wilton Boulevard and School Bell Road. At the intersection of US 40 and School Bell Road (**Photo 10**), recently completed work has provided crosswalks on the south side of US 40, as well as across School Bell Road. Over the course of a day, three

pedestrians were observed crossing US 40 on the crosswalk (**Figure 7**). No pedestrians were seen crossing outside of the crosswalk at this location.

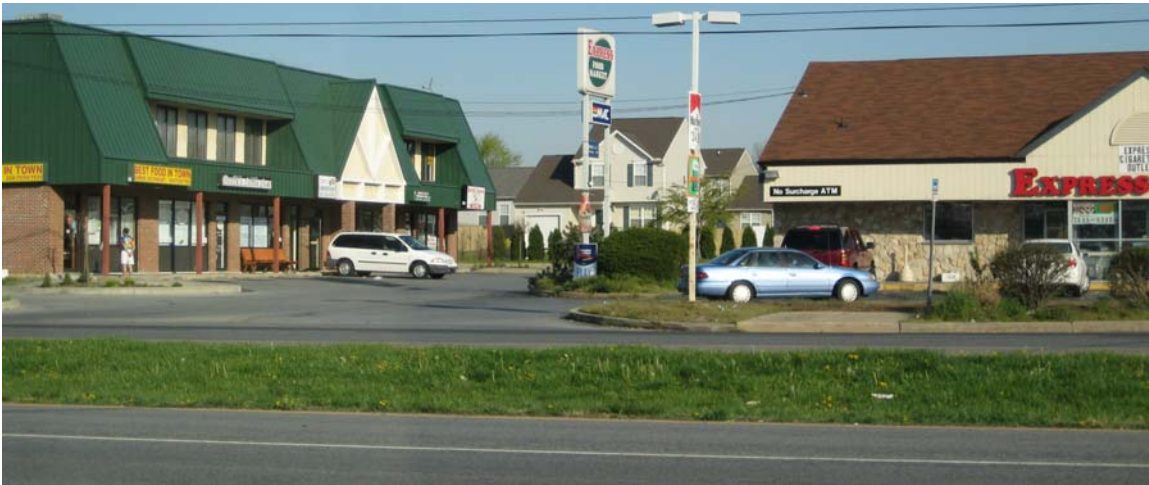
Photo 12: Convenience Store on US 40 near Fir Avenue

A total of 33 pedestrians were observed crossing US 40 mid-block between Fir Avenue and Contractors way (approximately 100-200 west of Fir Avenue). Based on observations, most of these pedestrians were going to and from the convenience store on the westbound side of US 40 (**Photo 12**).

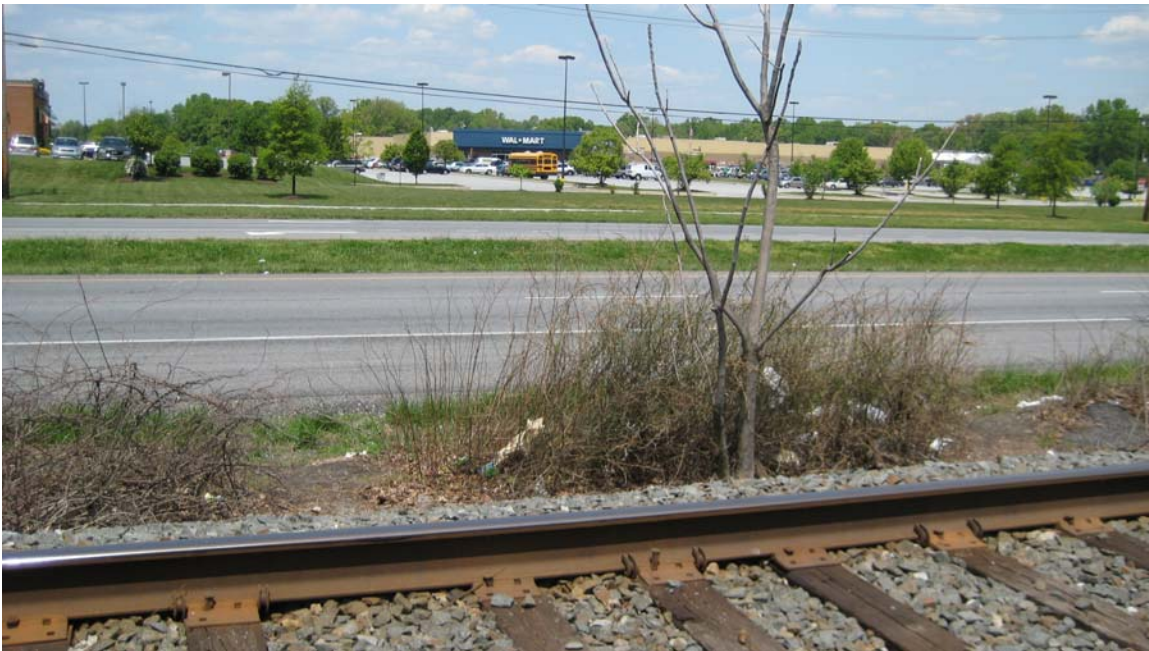
Photo 14: US 40 East of Wilton Boulevard

On US 40, the highest number of crashes (49) occurred at the intersection with Wilton Boulevard. This is also the location with the highest number of pedestrian related crashes. There were 26 crashes over the three year period at the intersection of US 40 with Fir Avenue (**Figure 9C**). These crashes included eleven angle crashes. There were no pedestrian related crashes at this intersection, however this is a location with high pedestrian activity.

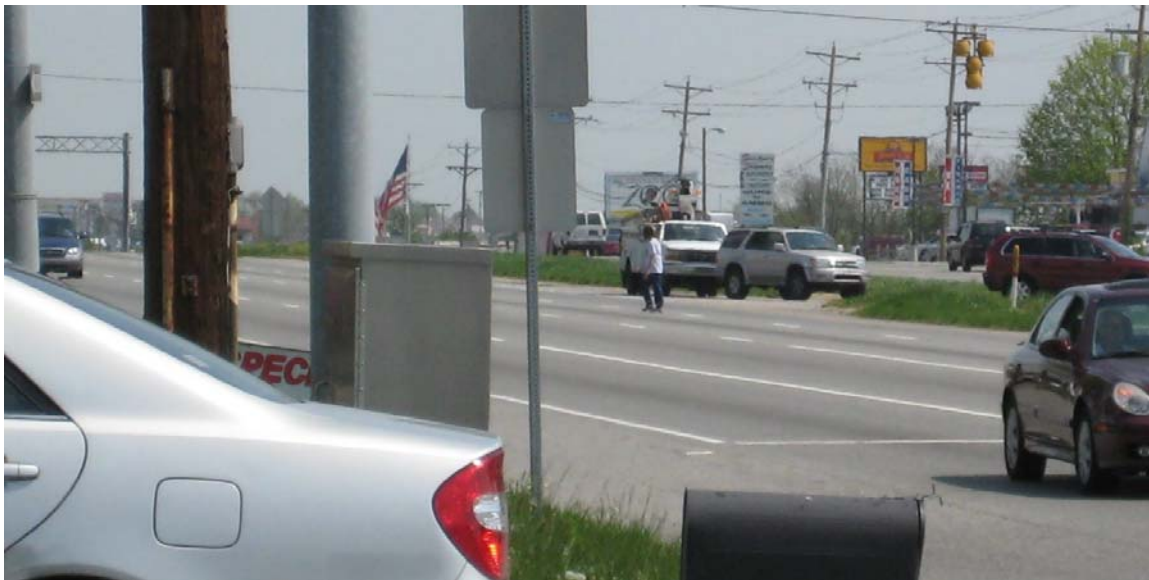
Photo 15: A pedestrian crossing US 13 in traffic

The lowest ISI for pedestrians was at the intersections of US 13 with Schafer Blvd and Buena Vista Dr while the highest were at the intersection of US 13 with US 40 and US 13 with DE 273. For bicyclists all of the ISI values were three or more (on a scale of 1(safest) -6(least safe), with a three at the intersection of US 40 and Fir Ave and the highest ISI in the study area (5.2) at the intersection of US 13 and DE 273.

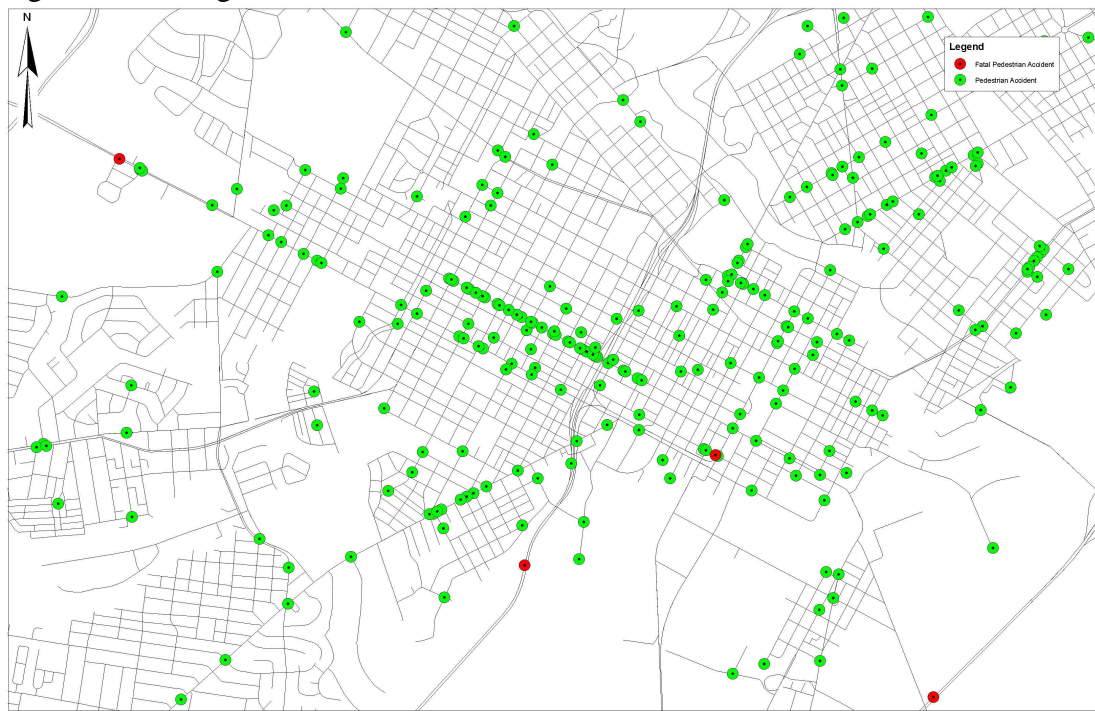
Figure 1-Wilmington Pedestrian Accidents

Research began with the Departments accident inventory system. This system catalogues accident reporting information provided by state and local police departments. Pedestrian accidents were selected from the overall inventory and mapped into an ArcGIS. An additional separation was made within the pedestrian accident field to differentiate between fatal and non-fatal accidents. The resulting GIS maps identified several corridors within the northernmost county (New Castle) with unusually highly concentrated clusters of pedestrian accidents (Fig 1, Fig 2)
